Army Lodging Wellness Recommendation

Fort McCoy - Final Submittal

August 21, 2003

Section 1 Wellness Recommendation

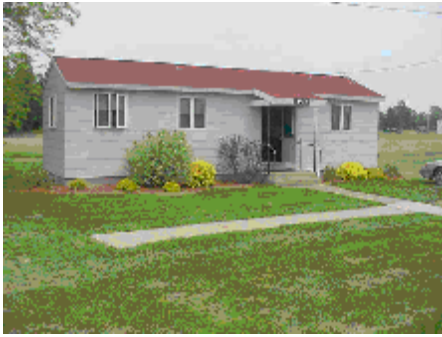
Building 105, constructed in 1942, is a single story structure housing a single 2-bedroom suite with a full kitchen at 550 square feet. The building is in poor condition and does not meet current Army Lodging standards. The cost to make condition assessment improvements will exceed 50% replacement cost.

Our recommendation is to remove building 105 from the Lodging inventory, allowing the installation to determine an alternate use for the facility. This facility will be removed from the Fort McCoy Wellness Solution and Lodging Master Plan.
